GEOTECHNICAL EVALUATION OF POTENTIAL MATERIAL SITES

SELECT LOCALES WITHIN THE GLENN & PARKS HIGHWAY CORRIDORS

**Prepared for
Matanuska Susitna Borough
Palmer, Alaska**

RECON Project No. 2021-162

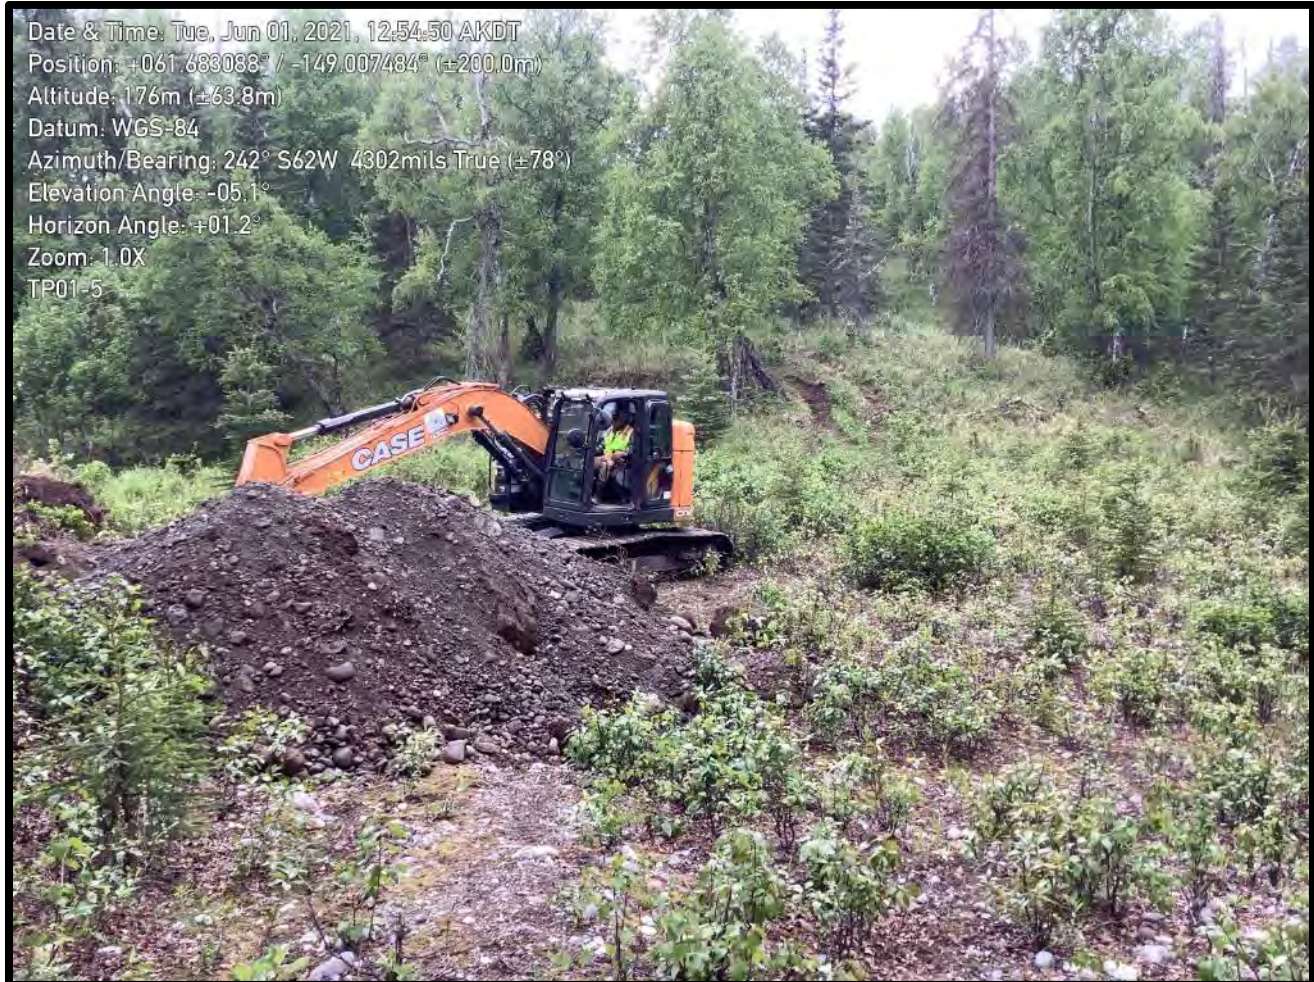
A total of six samples were collected: one from each test pit. A sieve analysis classified the material as poor to well-sorted gravel with sand. A degradation value of 85 was obtained from sample TP01-5. This test result is very promising, as most crushed products require a minimum degradation value of 45. See Appendix C for material test results

Figure 1. TP01-5 displaying typical material and vegetative cover.

The results from the material testing indicate that this gravel source has potential to meet specification for select Type A material and crushed aggregate products for highway construction projects. The test pits indicate that this potential borrow source could produce consistent, uniform material. Preliminary calculations indicate this site may potentially produce up to 5.5 million cubic yards of suitable material. Based on the preliminary subsurface investigation and material test results, RECON concludes that these parcels have significant potential as a borrow source and that further investigation of the site is justified.

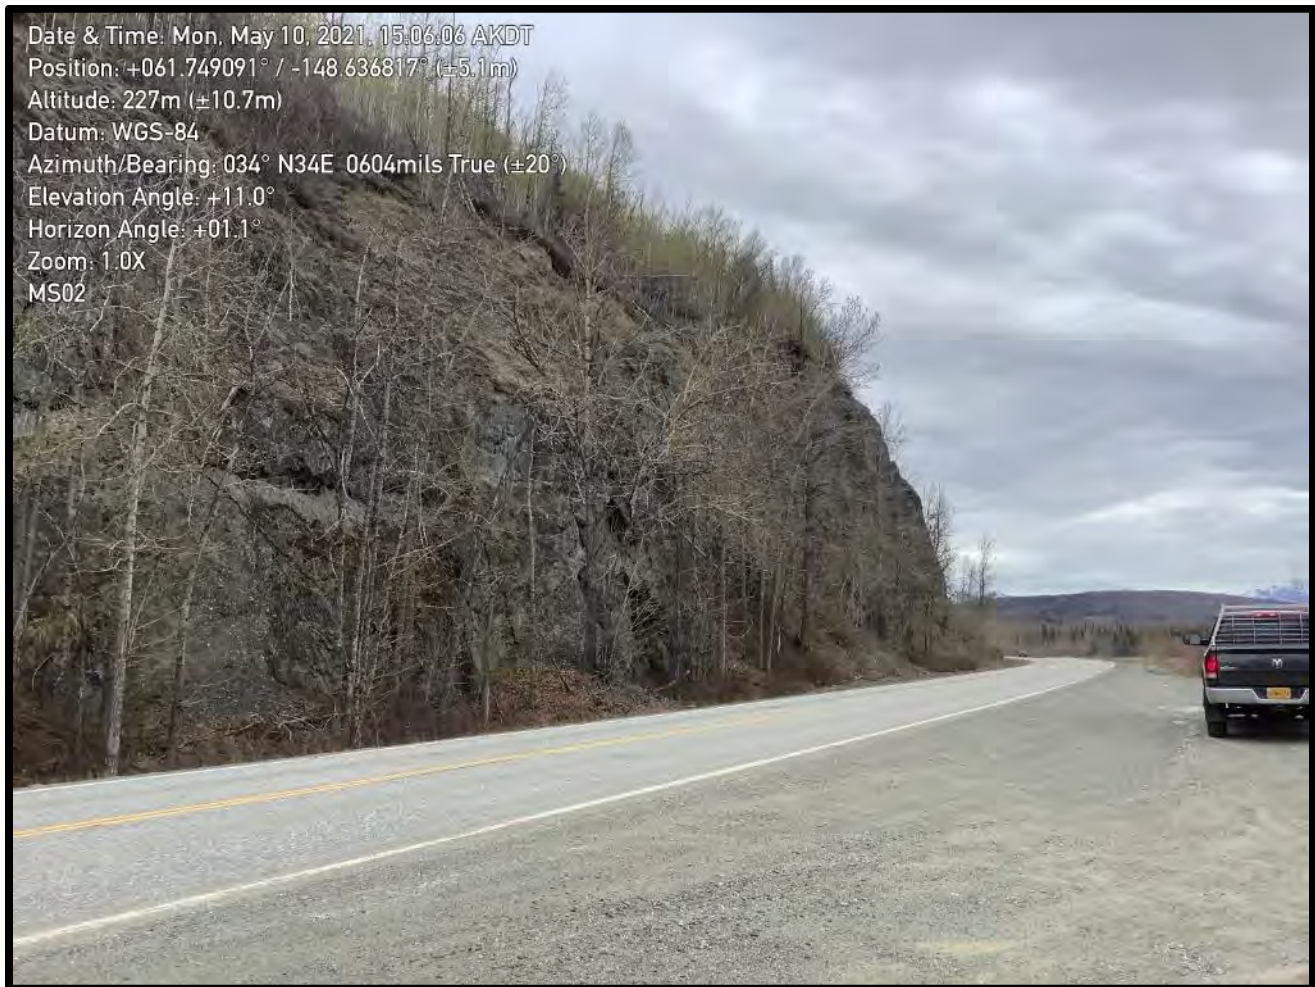
Based on RECON’s research and preliminary site investigation, this parcel has **no** significant potential as a gravel or quality rock source. RECON does not recommend any additional geotechnical investigation for this parcel.

Figure 2. Rock outcrop on Glenn Highway adjacent to MS02.

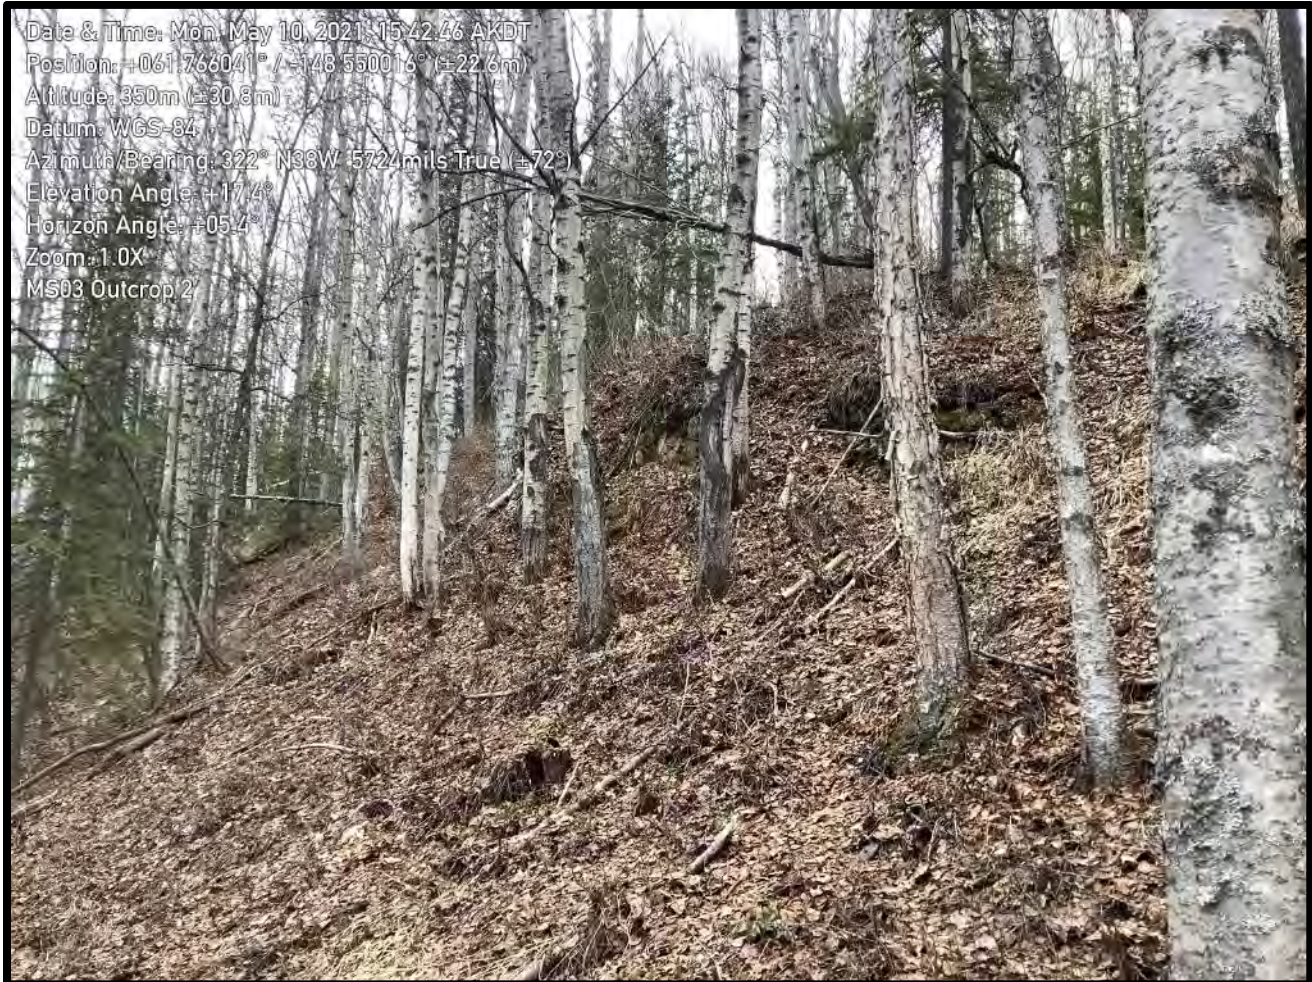
Accessing this parcel would require significant effort due to the steep terrain and distance to the highway. Based on RECON's investigation, this site has *no* significant potential as a quality rock source or borrow site.

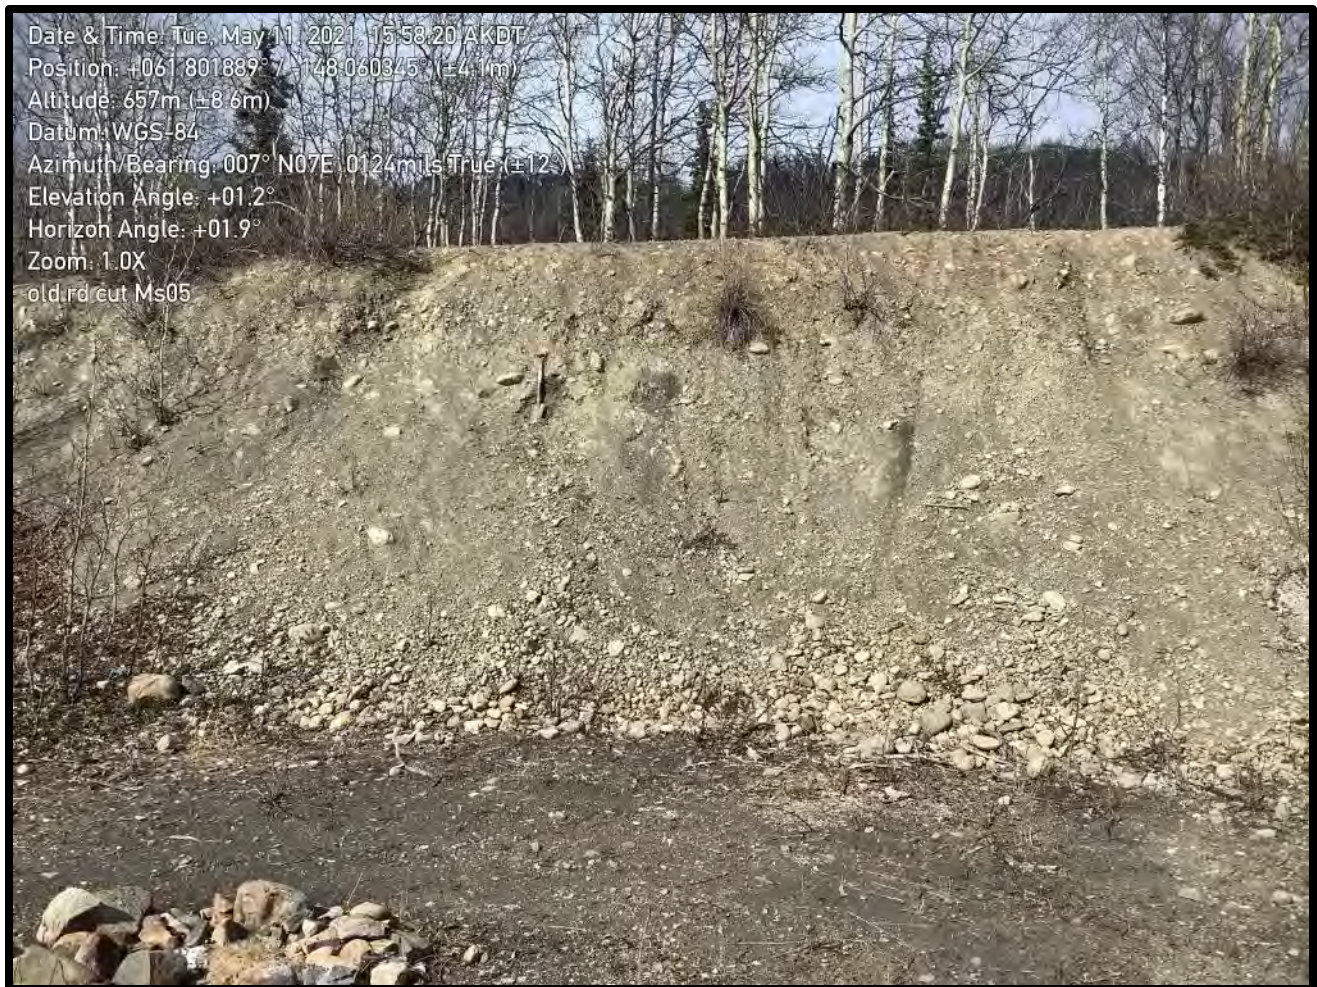
RECON hand-dug two test pits, both in the northeast corner of the parcel, one on the edge of each relic river terrace. The overburden is minimal (<12”) and consists of a sandy silt. The small pits dug indicate that the terraces contain well-sorted, weathered, silty-sandy gravels. A degradation and L.A. Abrasion test resulted in 37 and 19% respectively. These results indicate that this gravel is unlikely to meet specification for any crushed aggregate products. See Appendix C for material test results.

Figure 7. A road cut in the vicinity of the MSB parcel that contains similar gravels as found in the relic river terraces in the MSB parcel.

RECON’s preliminary geotechnical evaluation indicates that this parcel has no significant potential as a borrow or quality rock source. RECON does not recommend any additional geotechnical investigation.

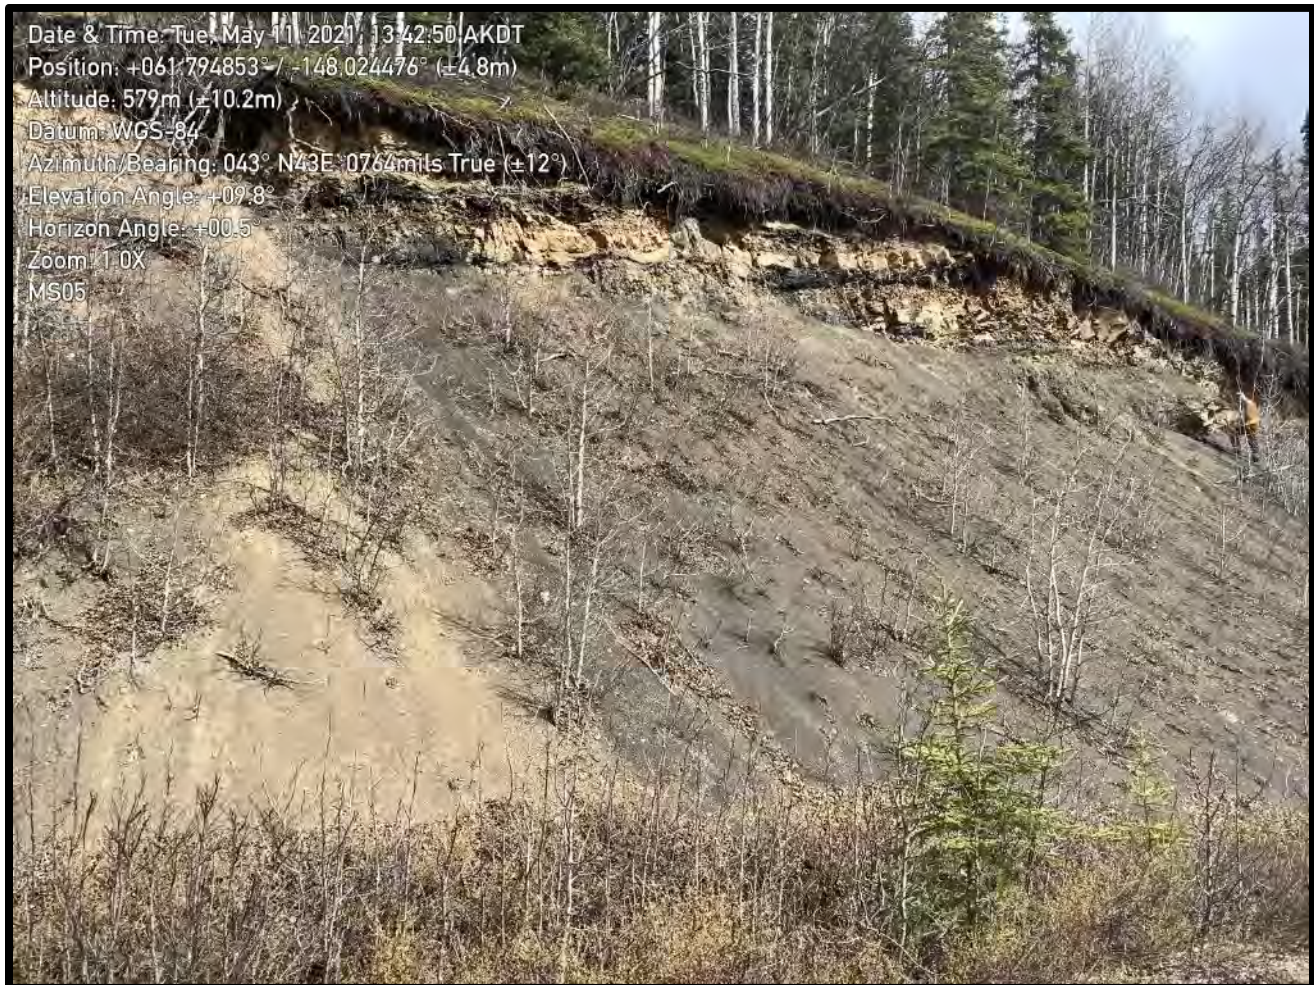
Exposed bedrock observed throughout the site was highly weathered sedimentary rocks.

Figure 8. Typical rock outcrop in MS05 site.

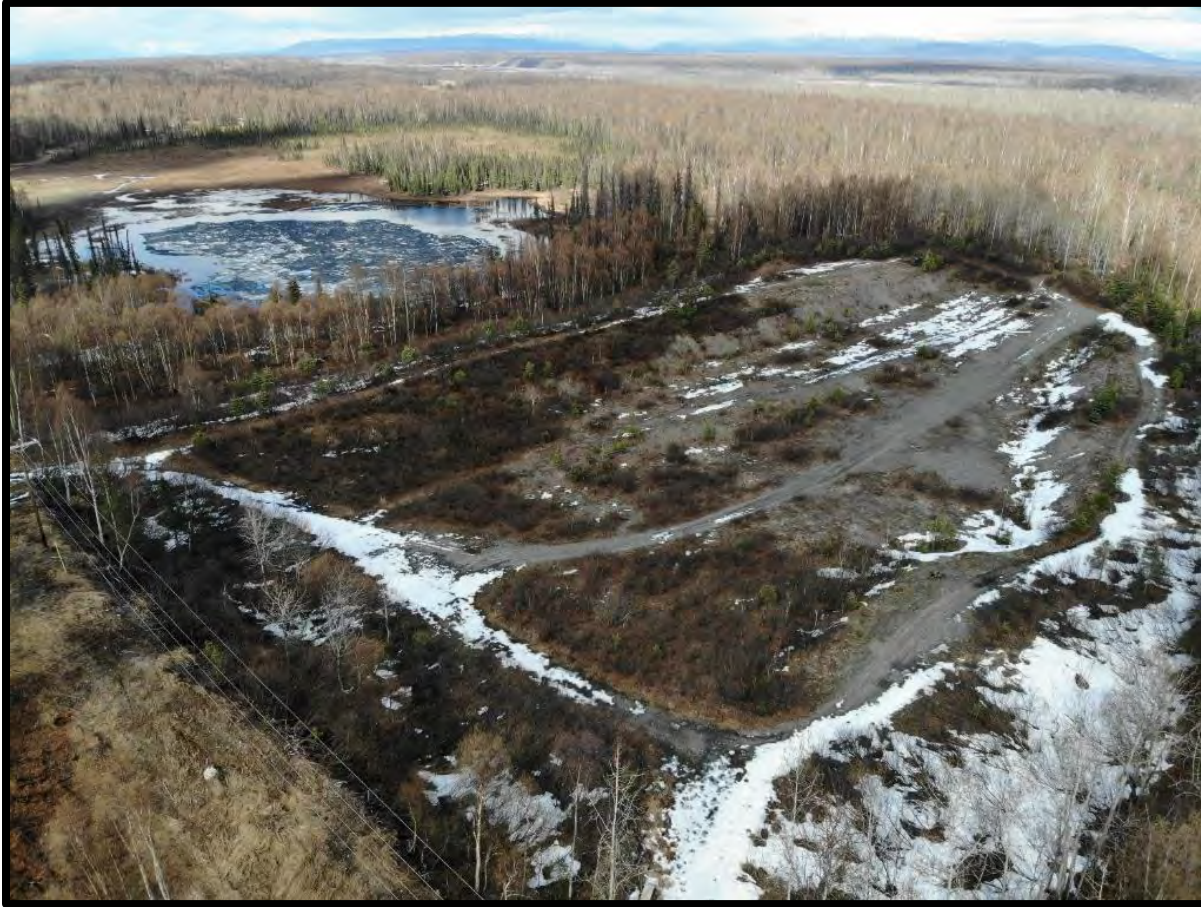
RECON's preliminary geotechnical evaluation indicates that this parcel has no significant potential has a borrow source. The existing borrow site has been mined to its limiting depth and the quantity of quality material remaining within the pit area is insignificant. RECON does not recommend any additional investigation.

Figure 10. MS07 – Inactive borrow site

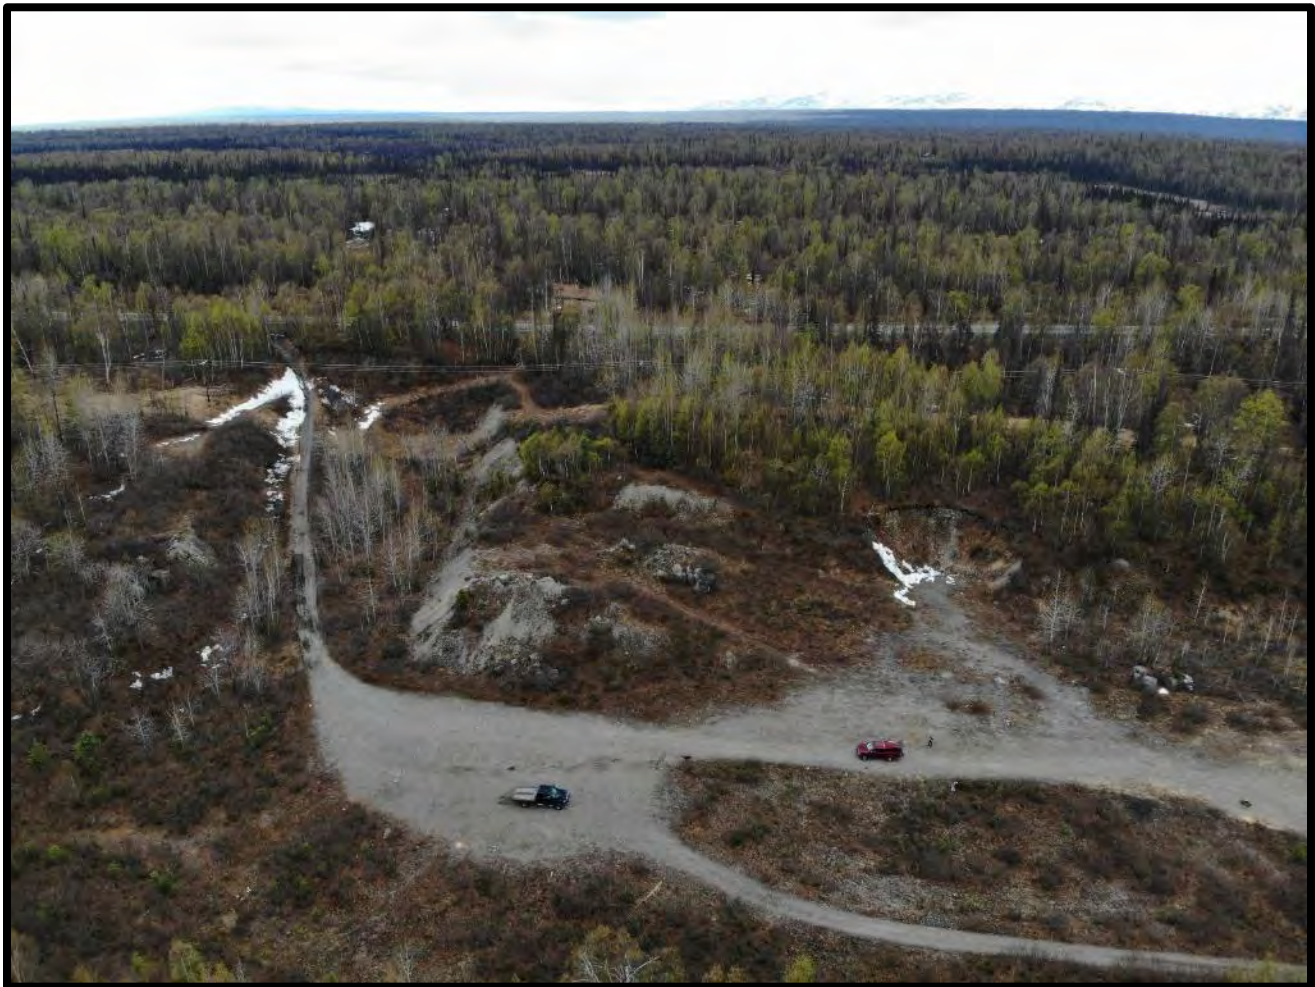
A total of six test pits were completed at this ranging from a total depth of 7.5 to 15-feet. The overburden averaged a depth of 1.5 to 3.0 -feet. See Appendix B for detailed test pit logs. The test pits and sieve analysis results indicate the subsurface conditions are inconsistent at this site. The material varied from well to poorly sorted, sandy gravel to silty sand with gravel. See Appendix C for material test results. Groundwater was observed in four of the six test pits, between 3 and 15-feet below the ground surface. The relic river terrace in the eastern parcel has some potential has a borrow source. Based on preliminary evaluations it may contain up to 56,000 cubic yards of material.

Figure 11. MS08 – Historic, inactive borrow site located on the western most parcel in the project area.

RECON's preliminary geotechnical evaluation indicates that this parcel has limited potential as a borrow or quality rock source. RECON does not recommend additional geotechnical investigation.
