GEOTECHNICAL EVALUATION OF POTENTIAL MATERIAL SITES

SELECT LOCALES WITHIN THE GLENN & PARKS HIGHWAY CORRIDORS

**Prepared for
Matanuska Susitna Borough
Palmer, Alaska**

RECON Project No. 2021-162

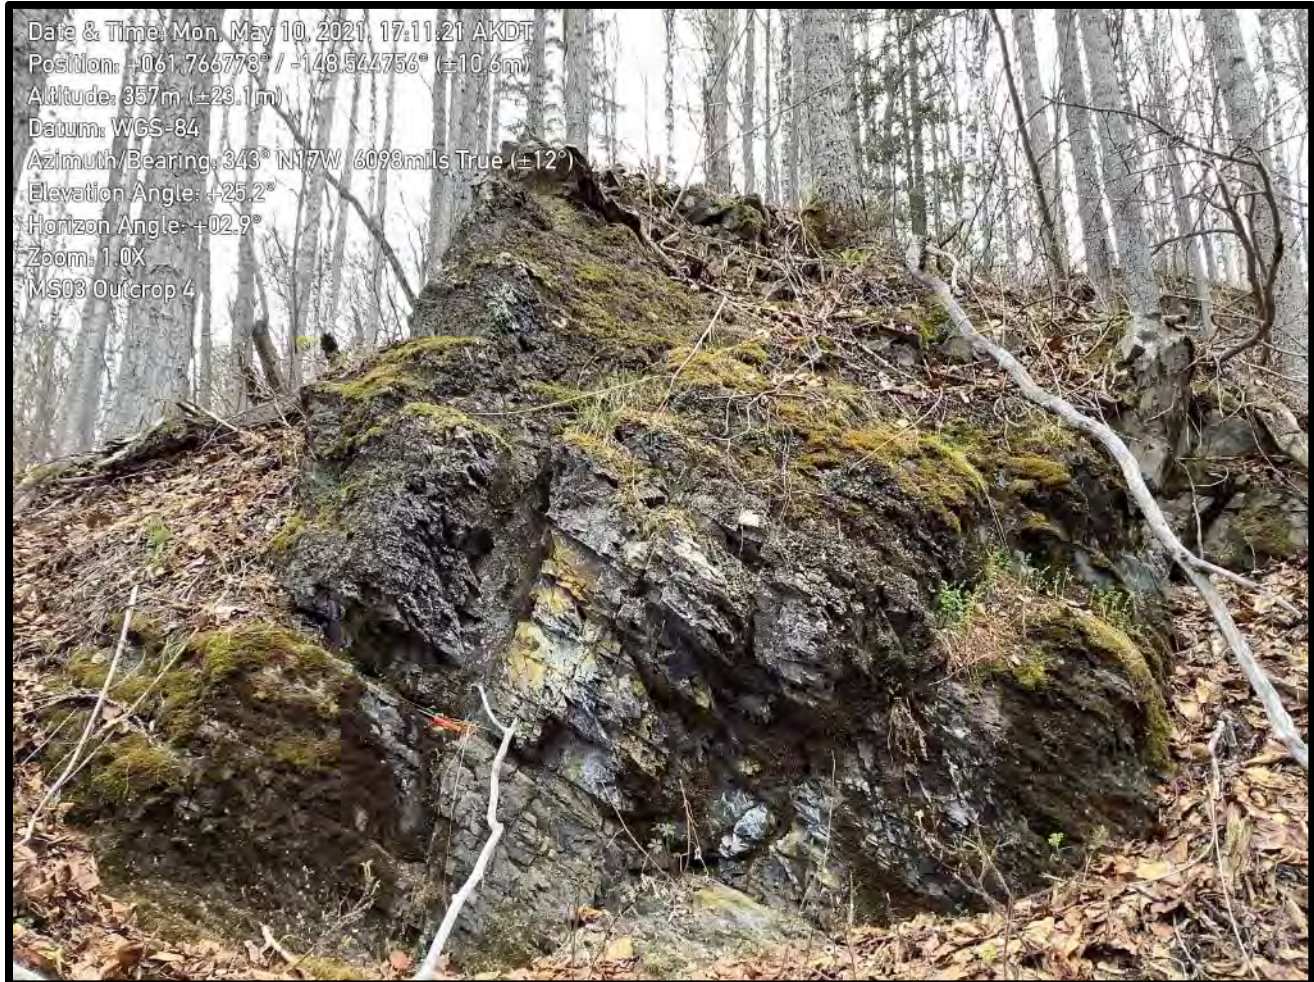
Figure 4. Outcrop 03-4

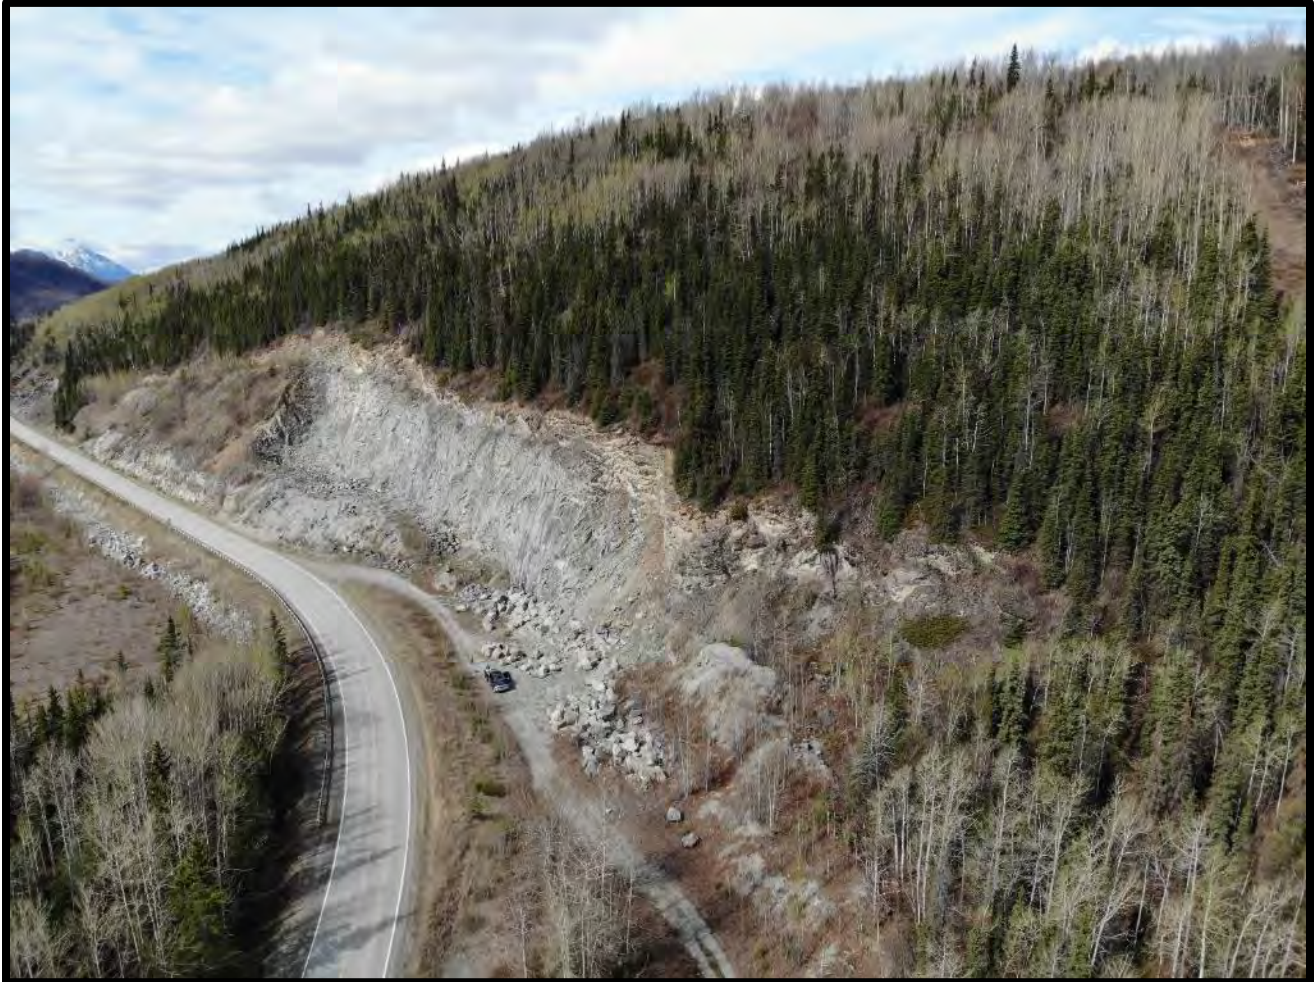
Figure 5. Aerial view of MS04 and the inactive quarry site.

Further investigation would require a comprehensive rock core drill program that would delineate the extent and quality of the granitic intrusive. Based on RECON's preliminary assessment, this site has significant potential as a quality rock source. If further investigation proves the rock quality and quantity, a detailed mine plan would be required due to proximity to the highway and steep terrain. Coordination with adjacent landowners is also recommended due to potential of a shared resource and limited area of the MSB parcels.

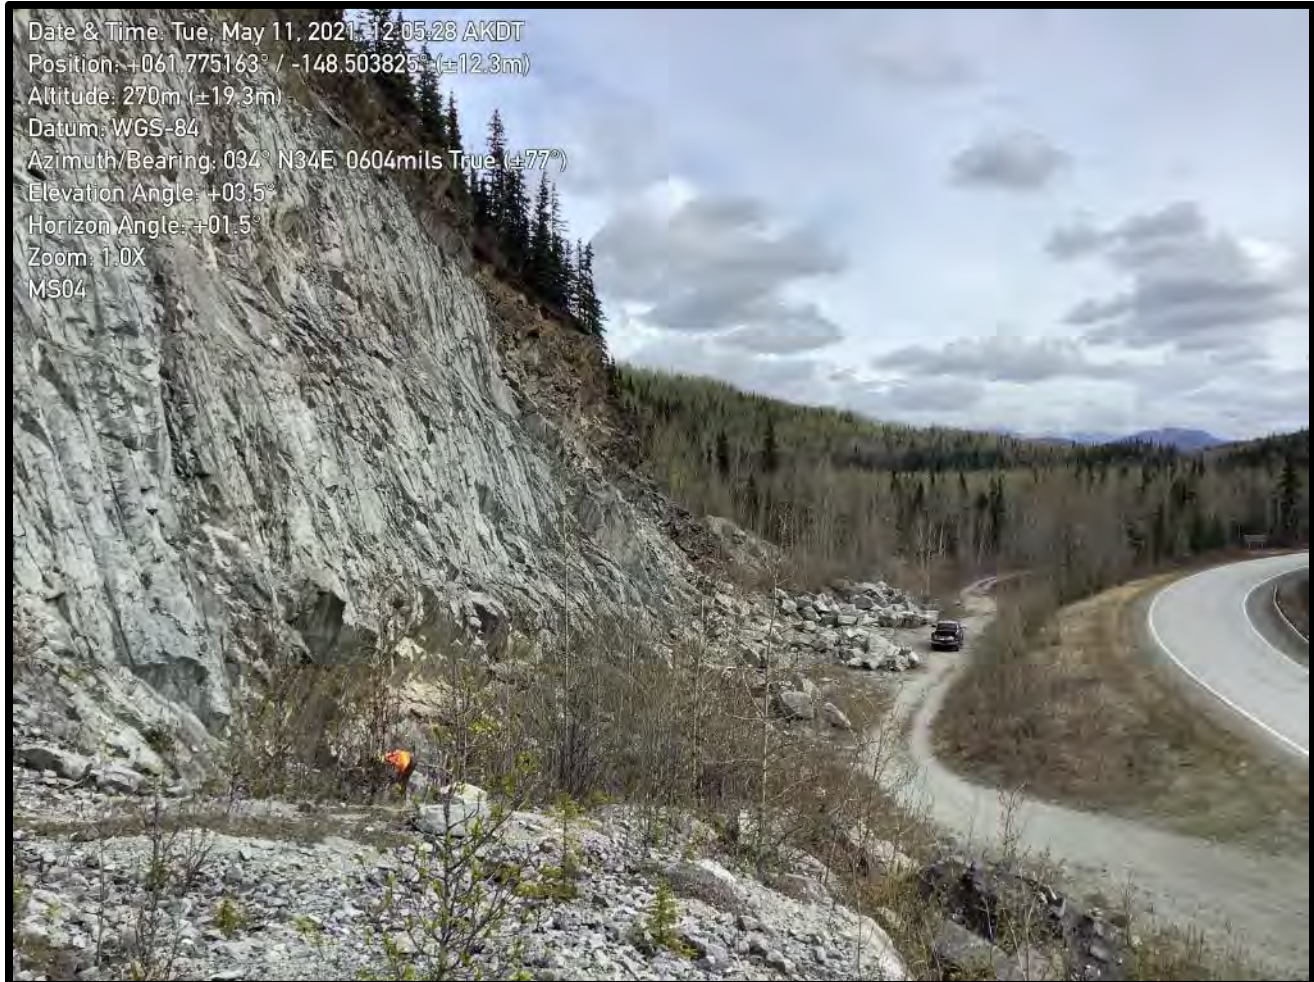
Figure 6. Inactive quarry site adjacent to MSB parcels.

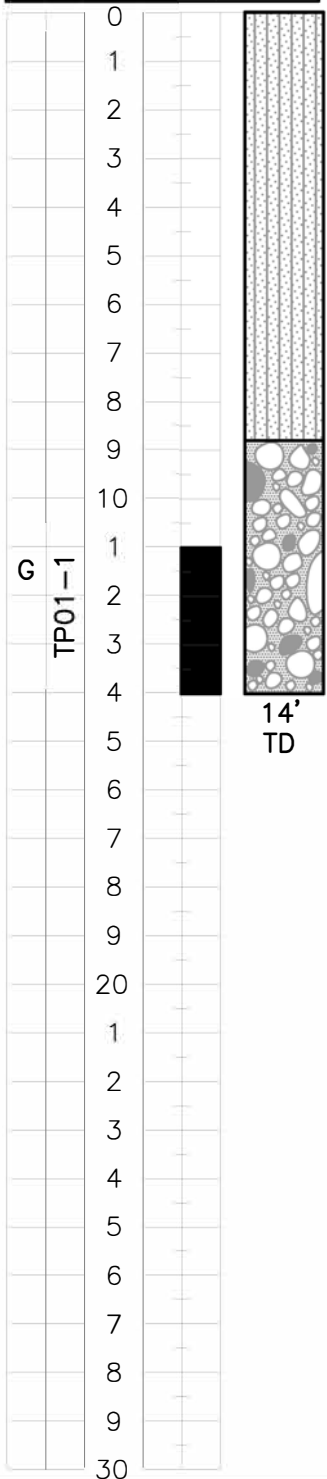
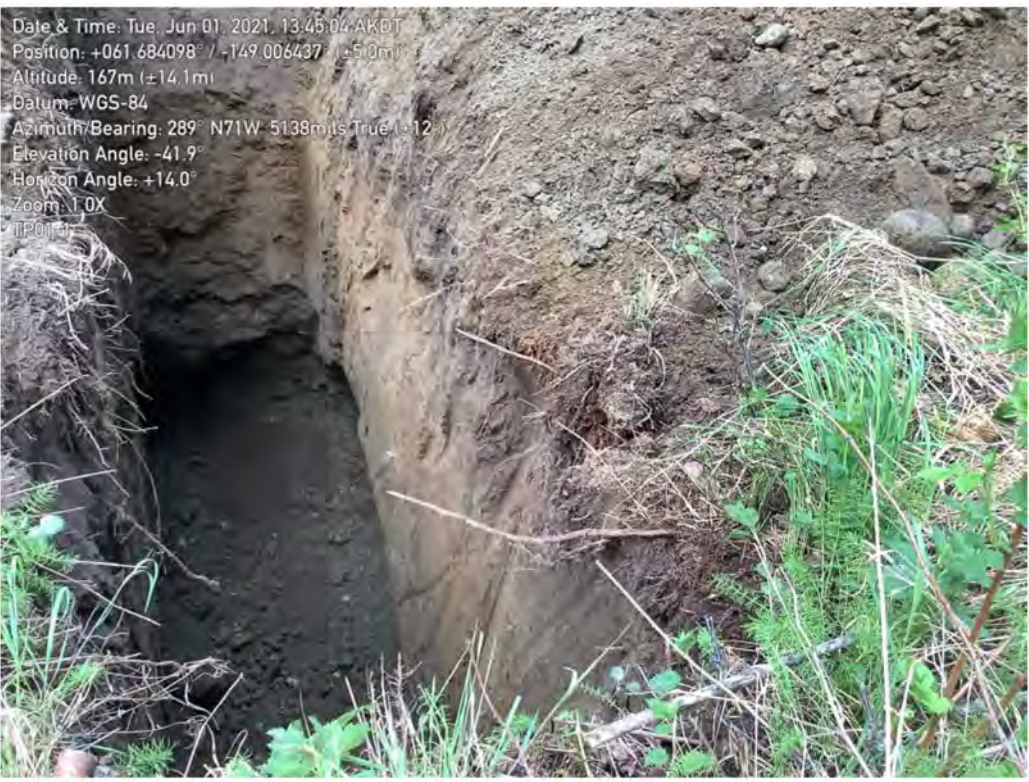
GEOLOGIC LOG TEST PIT: TP01-1

0.0' – 8.8' Sandy silt, soft to med. firm, dark brown, moist. Trace organics.

8.8 – 14.0' Well sorted, sandy cobble gravel w/ boulders, moderately dense, dry, boulders to dia. 36". Clasts subrounded to rounded, granitic, un-weathered to slightly weathered.

Notes: No groundwater observed at time of excavation. Coordinates from hand held GPS. Ground elevation from MSB 2011 LiDAR data. Terrain is a large depression within a hilly glacial outwash plain.

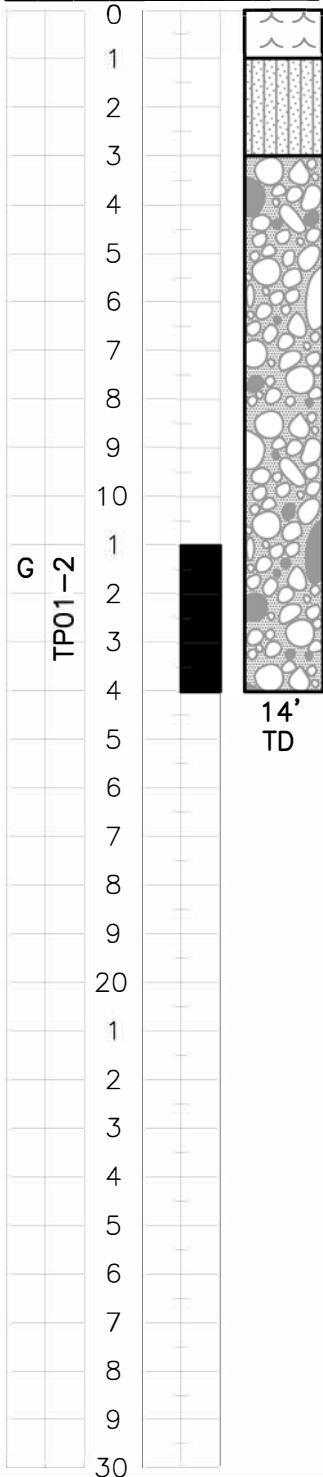
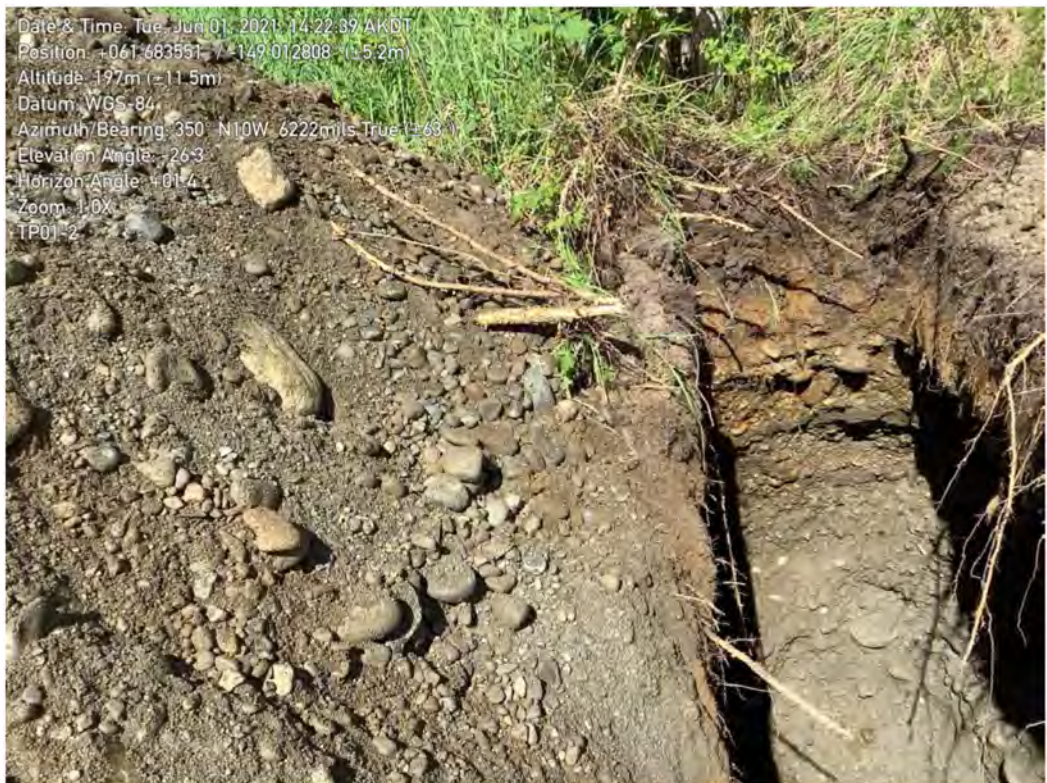
GEOLOGIC LOG TEST PIT: TP01-2

0.0' – 1.0' Organic silt, moderately firm to firm, dark brown, moist.

1.0' – 3.0' Sandy silt, med. firm to firm, brown, damp.

3.0' – 14.0' Well sorted, sandy cobble gravel w/ boulders, moderately dense, dry, boulders to dia. 24". Clasts subrounded to rounded, granitic, un-weathered to slightly weathered.

Notes: No groundwater observed at time of excavation. Coordinates from hand held GPS. Ground elevation from MSB 2011 LiDAR data. Terrain is a NW-SE trending ridge

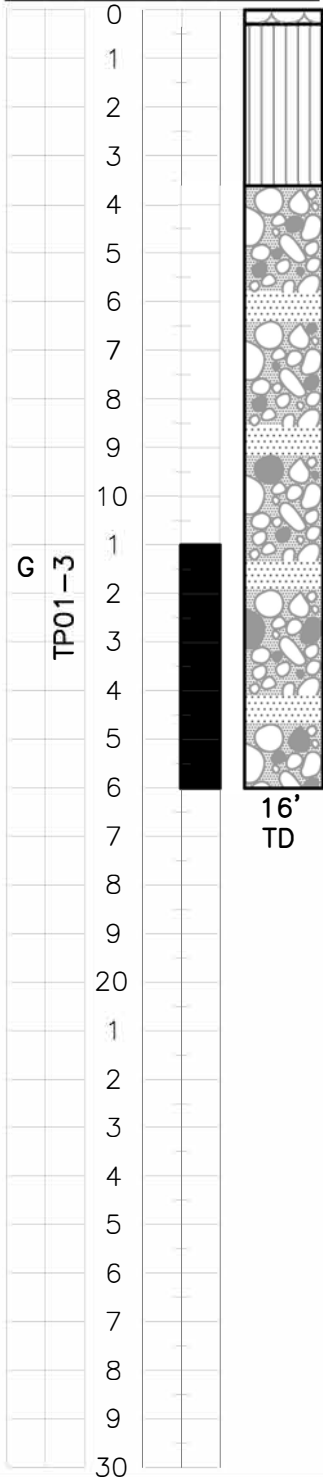
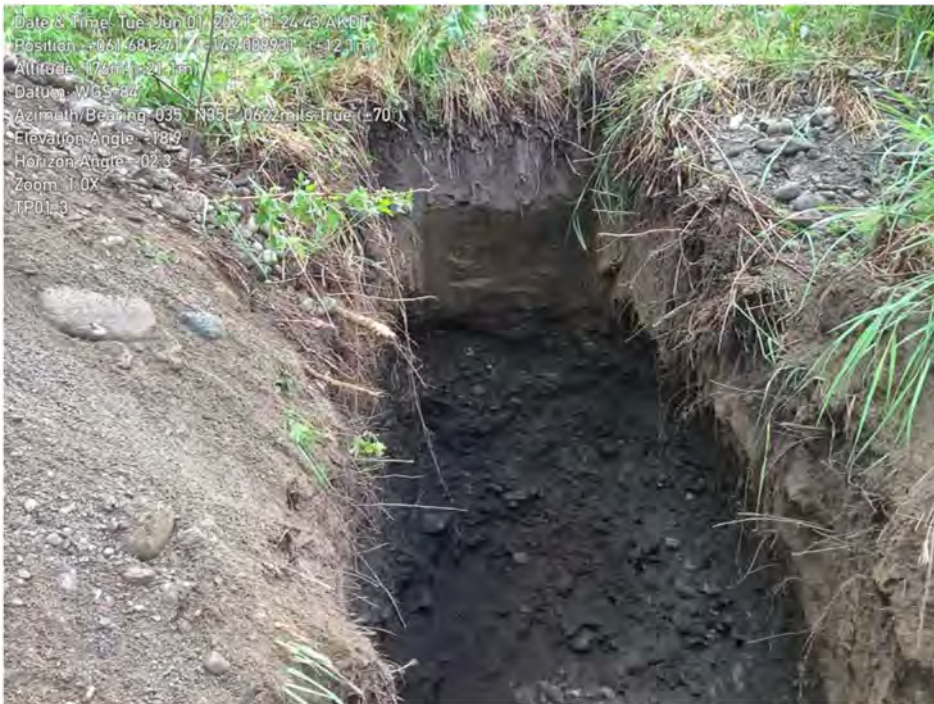
GEOLOGIC LOG TEST PIT: TP01-3

0.0' - 0.2' Organic mat and decaying organic material, very soft, moist, dark brown

0.2' - 3.6' Silt, brown, med. firm to firm, damp

3.6' - 16.0' Stratified, well sorted, sandy cobble gravel w/ boulders, moderately dense, dry, boulders to dia. 36". Trench walls sloughing while excavating. Clasts subrounded to rounded, granitic, un-weathered to slightly weathered.

Notes: No groundwater observed at time of excavation. Coordinates from hand held GPS. Ground elevation from MSB 2011 LiDAR data. Terrain is a SW facing slope, approx. 20%

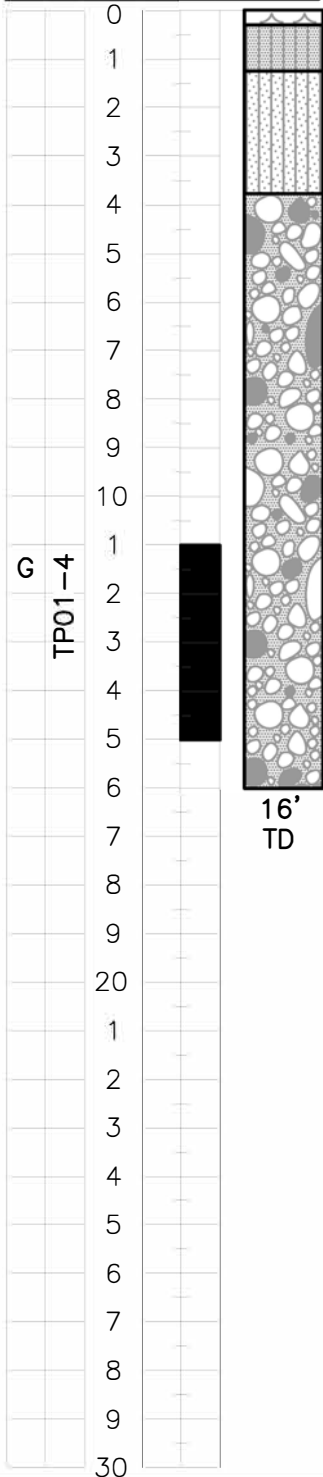
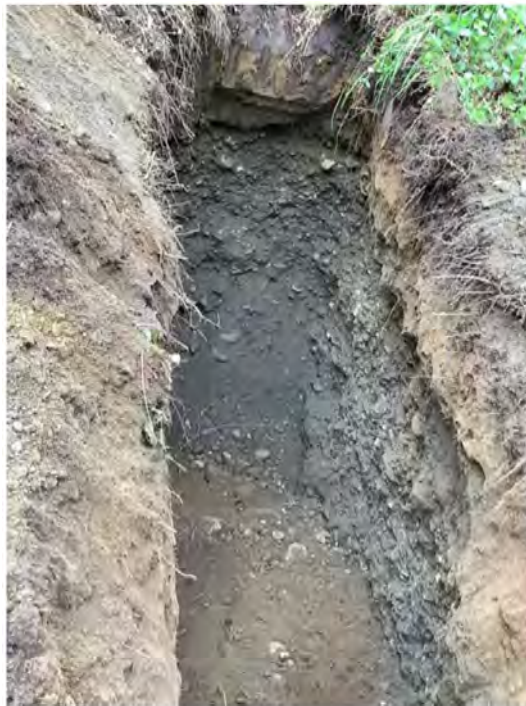
GEOLOGIC LOG TEST PIT: TP01-4

0.0' - 0.3' Organic mat and decaying organic material, very soft, moist, dark brown

0.3' - 1.2' Sandy silt, dark brown, med. firm to firm, damp

3.8' - 16' Well sorted, sandy cobble gravel w/ boulders, moderately dense, dry, boulders to dia. 36". Trench walls maintained during excavation. Clasts subrounded to rounded, granitic, un-weathered to slightly weathered.

Notes: No groundwater observed at time of excavation. Coordinates from hand held GPS. Ground elevation from MSB 2011 LiDAR data. Terrain is flat area in a small saddle between 2 small hills.

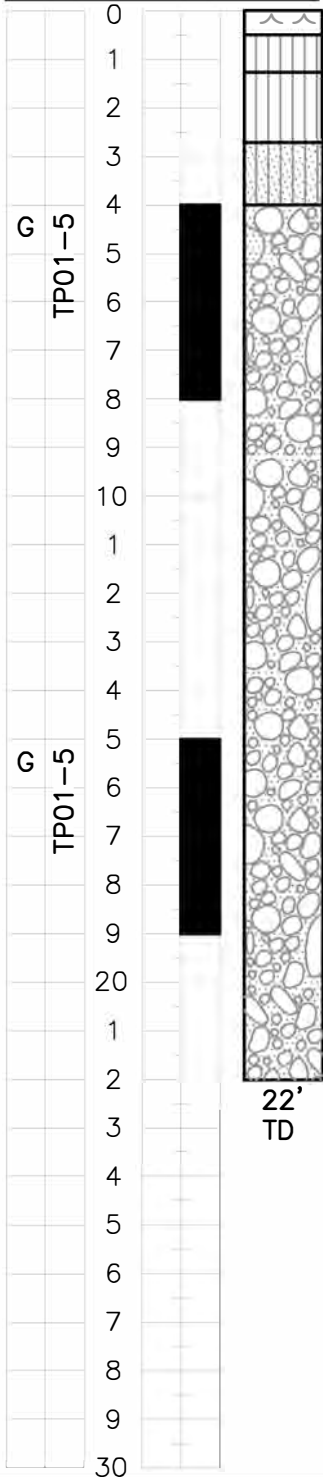
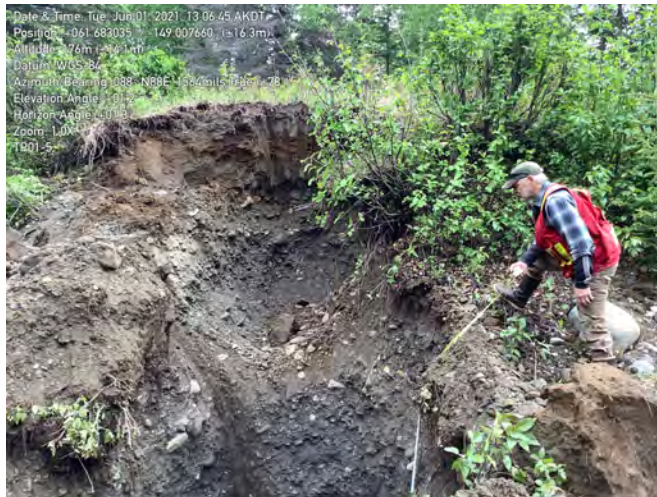
GEOLOGIC LOG TEST PIT: TP01-5

0.0' - 0.5' Organic mat and decaying organics, dark brown, very soft, moist

0.5' - 1.3' Silt, dark brown, soft to med. firm, damp

3.7' - 22.0' Well sorted, sandy cobble gravel w/ few boulders, moderately dense, dry, boulders to dia. 18". Trench walls maintained during excavation. Clasts subrounded to rounded, granitic, un-weathered to slightly weathered.

Notes: No groundwater observed at time of excavation. Coordinates from hand held GPS. Ground elevation from MSB 2011 LiDAR data. Terrain consist of a small, old borrow site. Located at toe of NW-SE trending asymmetrical ridge.

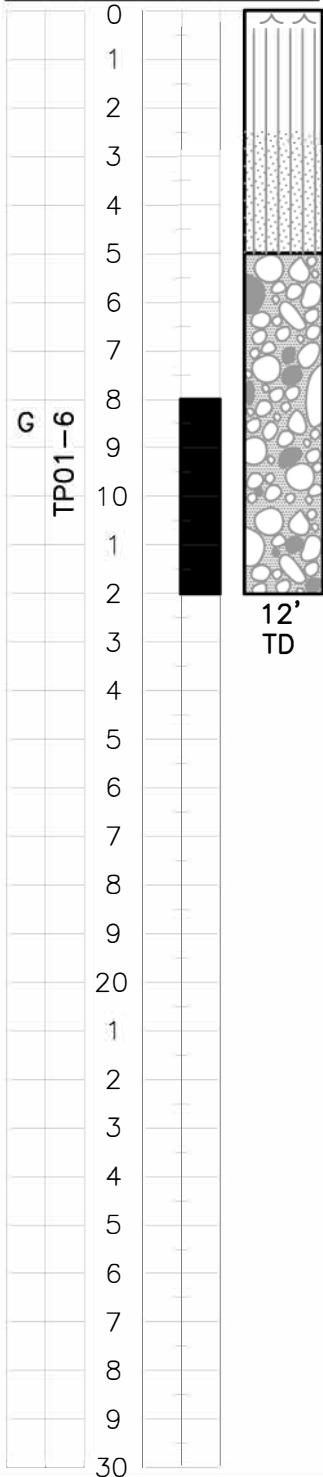
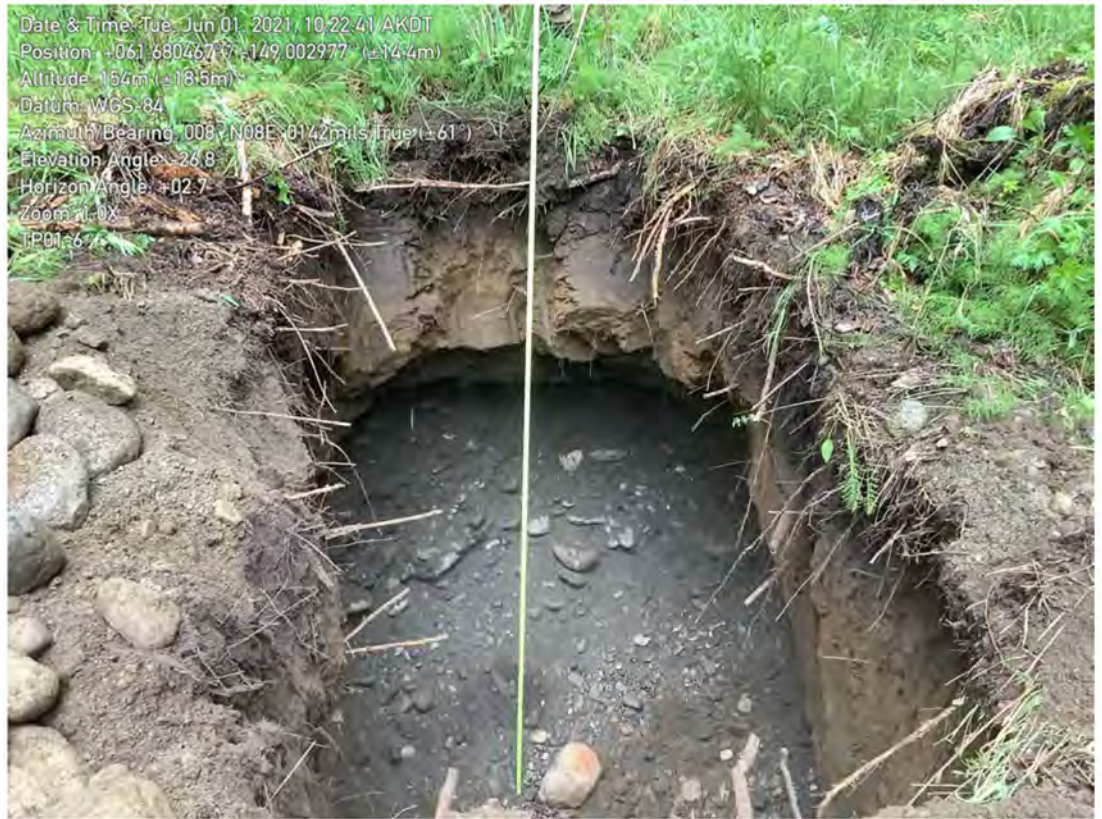
GEOLOGIC LOG TEST PIT: TP01-6

0.0' - 5.0' Silt to sandy silt, dark brown to tan, very soft to med. firm, moist to damp

5.0' - 12.0' Well-sorted, sandy cobble gravel w/ few boulders, moderately dense, dry to damp, boulders to dia. 18". Significant sloughing of trench walls during excavation. Clasts subrounded to rounded, granitic, un-weathered to slightly weathered.

Notes: No groundwater observed at time of excavation. Coordinates from hand held GPS. Ground elevation from MSB 2011 LIDAR data. Terrain consists of a narrow bench between 2 small ridges.

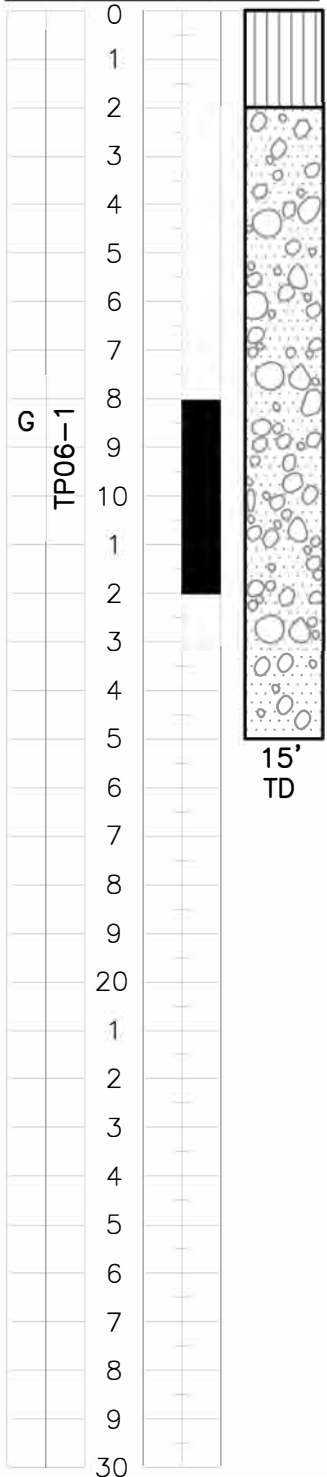
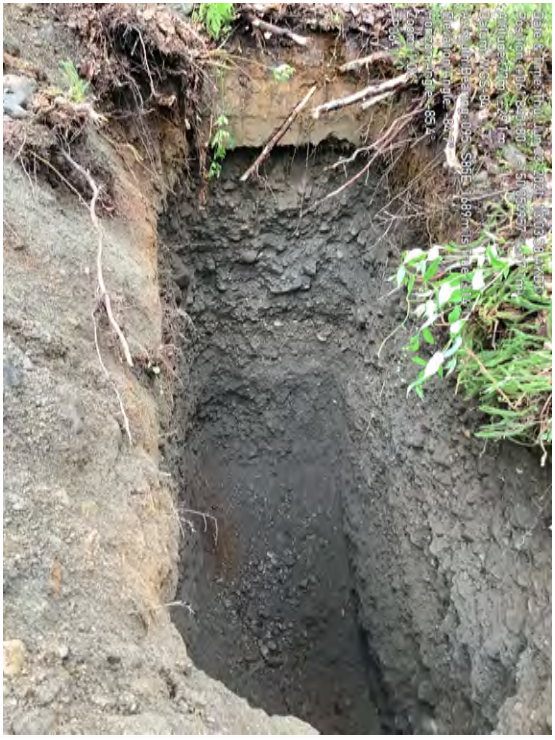
GEOLOGIC LOG TEST PIT: TP06-1

0.0' – 2.0' Silt, brown, soft to med. firm, moist. Trace organics.

2.0' – 15.0' Well sorted, coarse sandy gravel w/ cobbles, dense, gray, dry

Notes: No groundwater observed at time of excavation. Coordinates from hand held GPS. Ground elevation from MSB 2011 LiDAR data. Terrain consist of a relic river terrace.

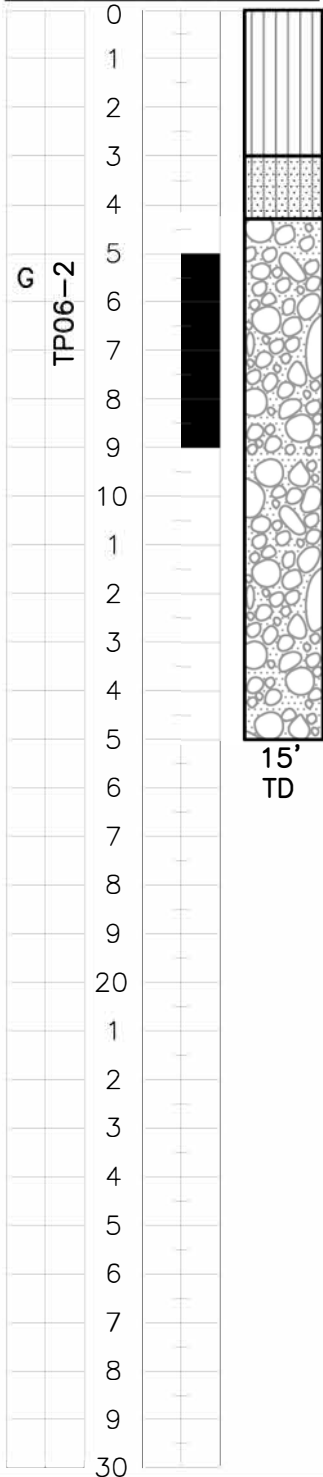
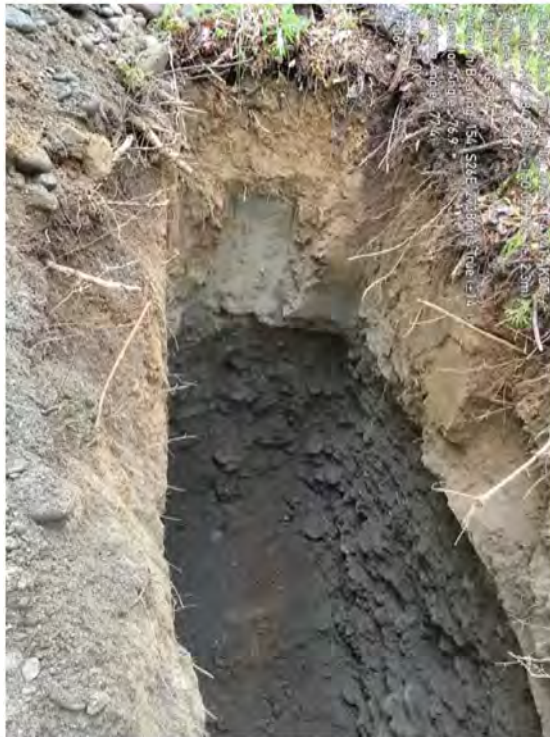
GEOLOGIC LOG TEST PIT: TP06-2

0.0' – 3.0' Silt, brown, soft to med. firm, moist. Trace organics.

3.0' – 4.3' Silty sand, gray med. firm to firm, dry

4.3' – 15.0' Well sorted, coarse sandy, cobble gravel w/boulders, boulder dia. up to 18–20", dense, dry. Min. sloughing near bottom of trench.

Notes: No groundwater observed at time of excavation. Coordinates from hand held GPS. Ground elevation from MSB 2011 LiDAR data. Terrain is a level area in a relic river channel.

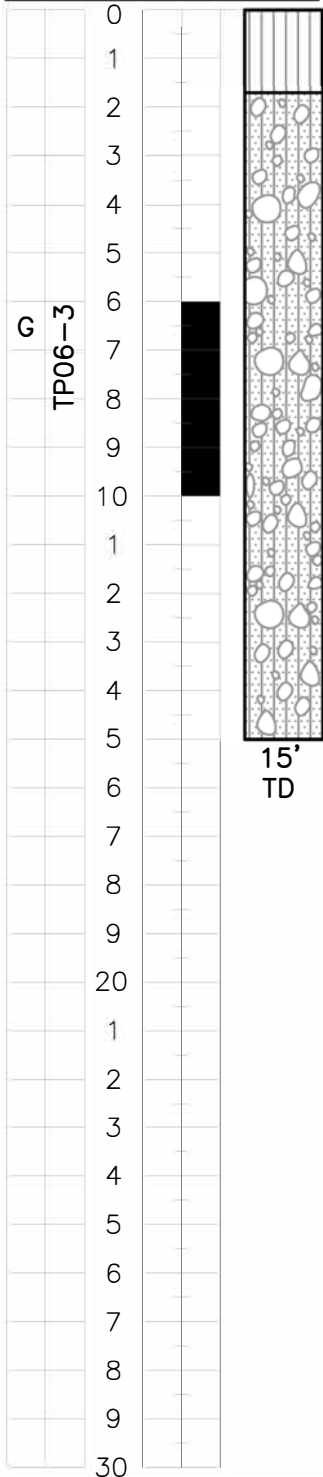
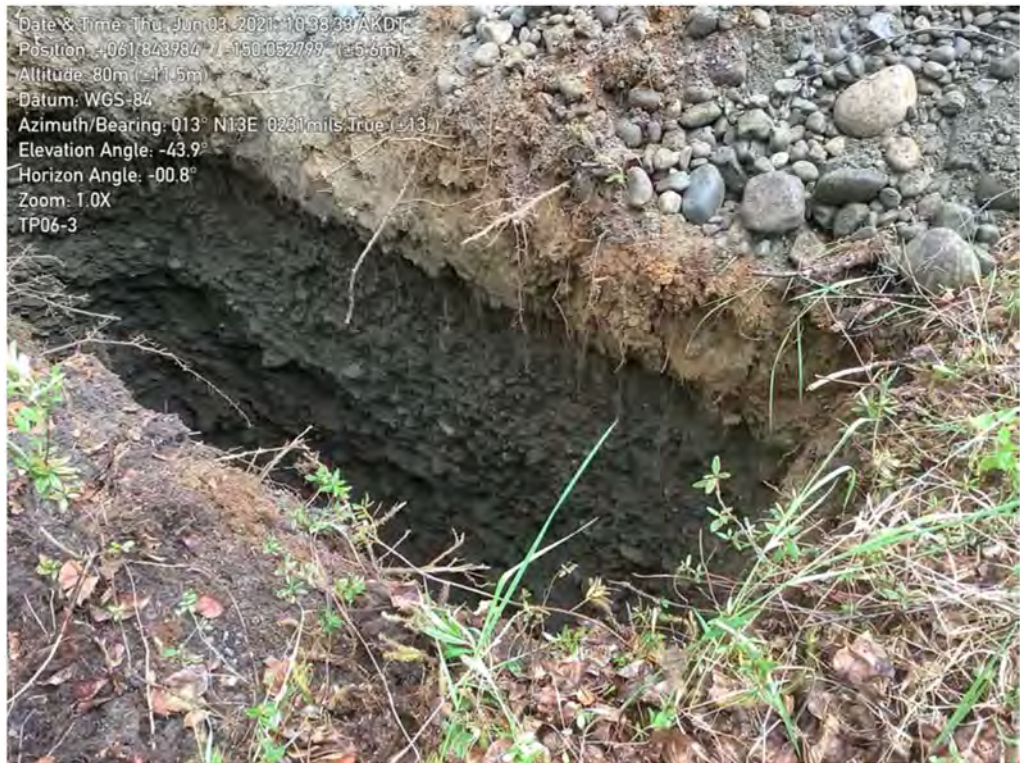
GEOLOGIC LOG TEST PIT: TP06-3

0.0' – 1.8' Silt, brown, soft to med. firm, moist. Trace organics.

1.8' – 15.0' Well sorted sandy, silty, gravel w/ cobbles, dense, dry. No boulders.

Notes: No groundwater observed at time of excavation. Coordinates from handheld GPS. Ground elevation from MSB 2011 LiDAR data. Terrain is a relic river terrace.

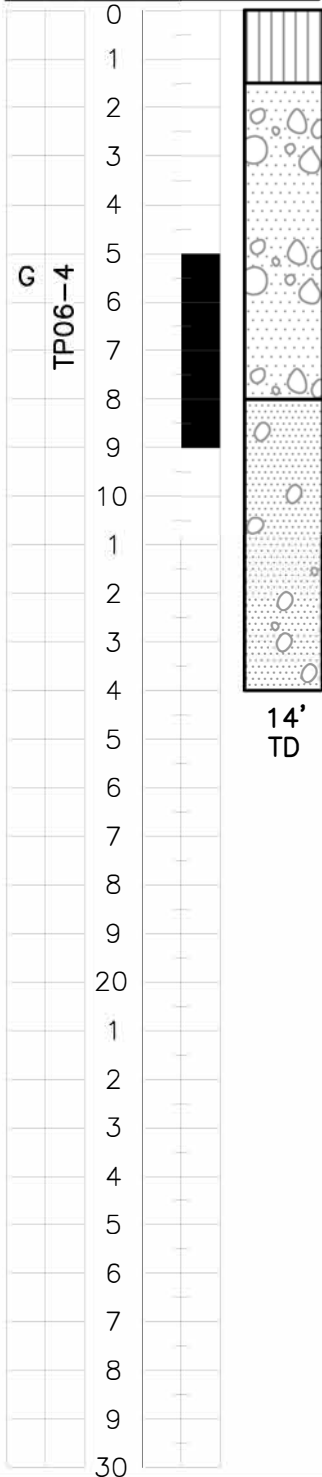
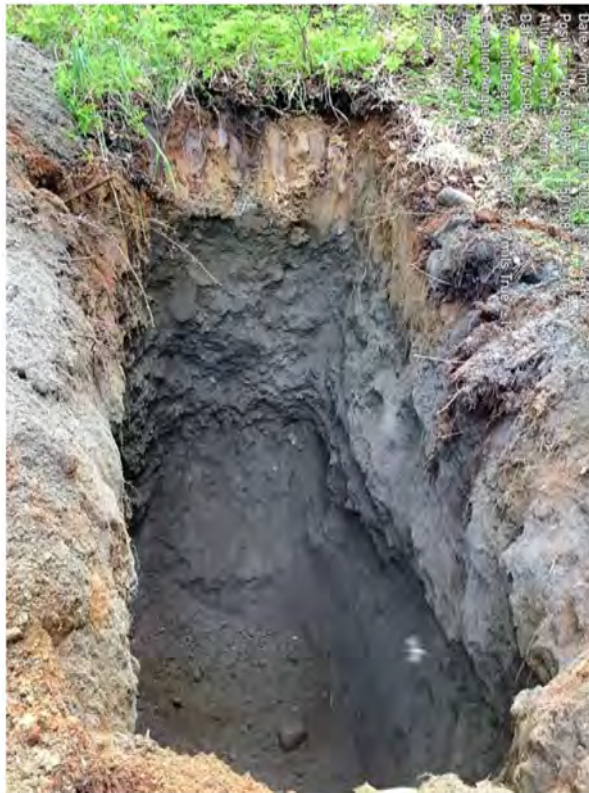
GEOLOGIC LOG TEST PIT: TP06-4

0.0' - 1.6' Silt, brown, soft to med. firm, moist. Trace organics.

1.6' - 7.9' Stratified, coarse sand w/ silt & gravel, gray, dense, dry

7.9' - 14.0' Medium grained sand w/ silt & gravel, gray, dense, dry

Notes: No groundwater observed at time of excavation. Coordinates from hand held GPS. Ground elevation from MSB 2011 LiDAR data. Test pit located on furthest E ridge top within the relic glacial moraine.
